White Etching Cracks

Position Paper
of the Gesellschaft für Tribologie e.V.
(German Society for Tribology)

Damage patterns, origin hypotheses,
influencing factors, risk assessment
and recommended actions

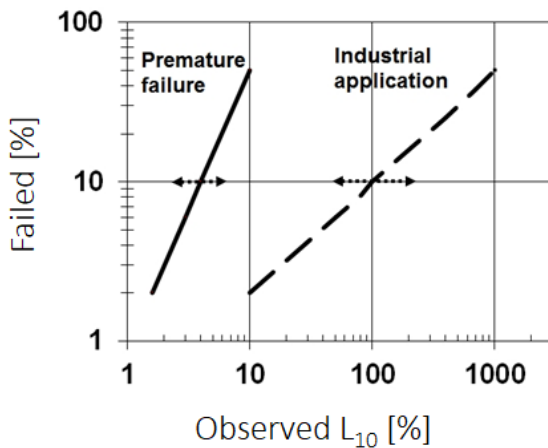
Fig. 2.1: Premature failures of rolling bearings due to WECs (Stadler et al. 2015b; Stadler et al. 2018)

Typical for WECs damage is an accumulation of damage with low variance (Fig. 2.1), as recognizable by the Weibull distribution.

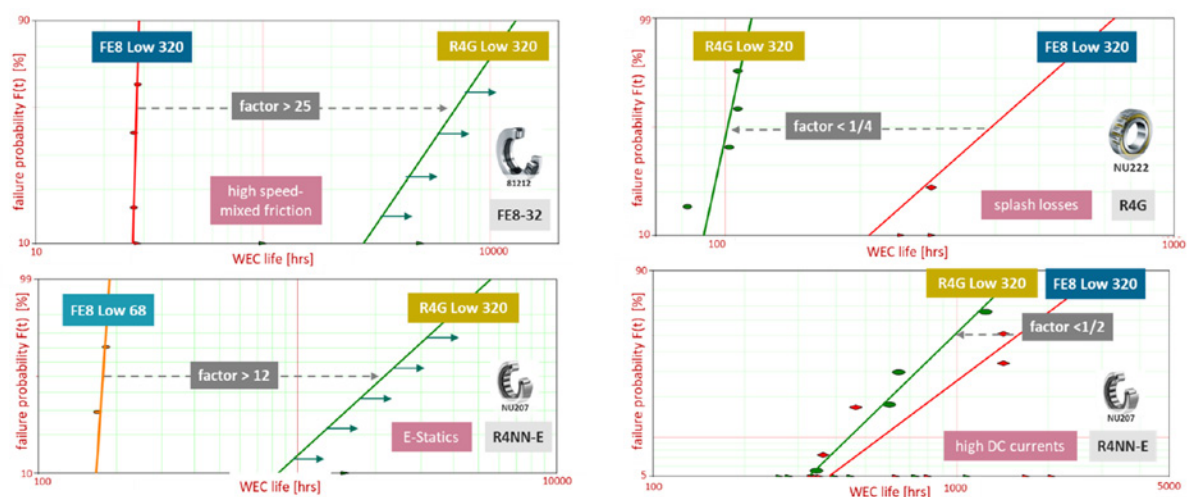
However, the impact of lubricant formulation on WEC inclination strongly depends on operating conditions and/or WEC trigger (see Fig. 4.3). Common WEC tests on the FE8 lubricant tester with axial cylindrical roller bearings („high-speed mixed friction“: mixed friction at the relatively high speed of 150 rpm) suggest either early failures (< 100 h e.g. with the „FE8 Low 320“ oil) or extended service life without WEC failure (> 500 h with „R4G Low 320“ oil). The so-called R4G test by Schaeffler (WEC failure at surface separation and high rolling element slip due to churning) demonstrates that the lubricant influence is distinctly less significant and the lubricant ranking is reversed. The service life of the test bearing NU222 without WECs using „FE8 Low 320“ oil is even longer than with „R4G Low 320“ oil. These two cases are also applicable for current-induced WEC damage. With the exception of „FE8 Low

68" oil, differing from „FE8 Low 320“ mainly in terms of viscosity (ISO VG 320 vs. 68), identical lubricants were used in WEC tests without bearing current. At very small DC currents ($< 100 \mu\text{A}$, „e-statics“) typical for electrostatic charges (e.g. induced by belt drives), the lubricant formulation has decisive influence, whereas this influence is rather insignificant for fatigue life tests at high bearing currents ($> 100 \text{ mA}$). All tests were conducted on the same test rig (R4NN) using the same bearing type NU205.

Fig. 4.3: Service life until WEC failure depending on lubricant and operating conditions (Loos et al. 2022) (Low: Oils with certain additives inducing WEC during the test procedure (mentioned in the oil name))

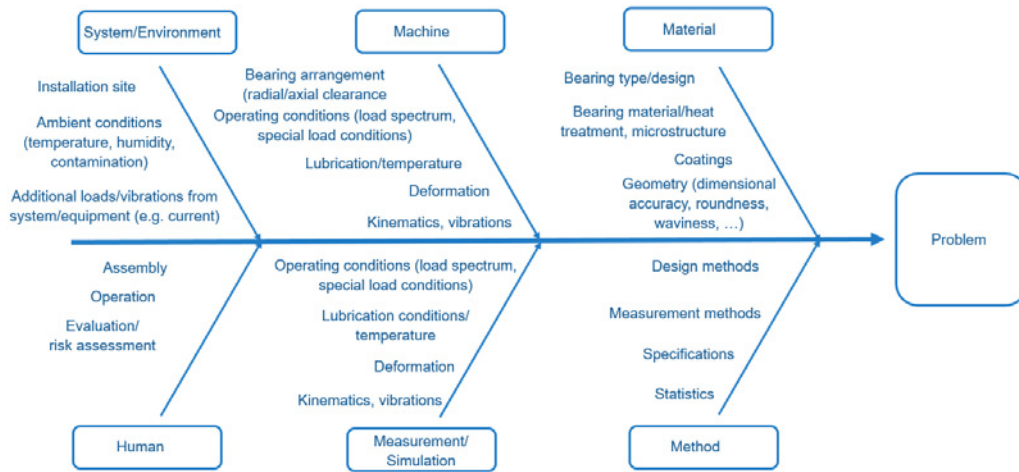
Fig. 5.2: "Generic fishbone" for component damage (HT - heat treatment)

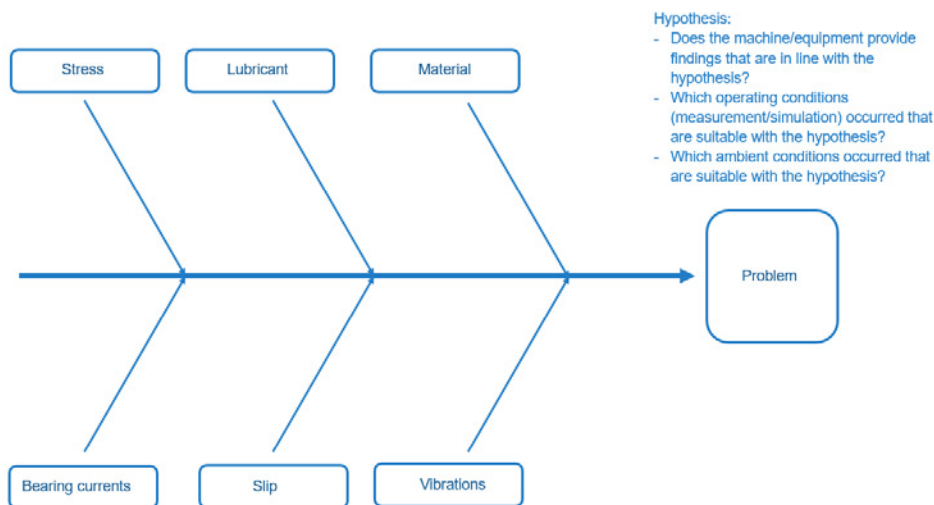
Fig. 5.3: "WEC Fishbone" (blueprint)
